[www.caa.co.uk/gasil](http://www.caa.co.uk/gasil)

Issue no 1 of 2010

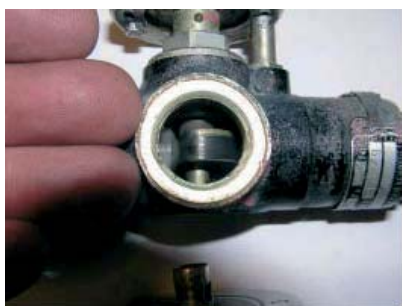
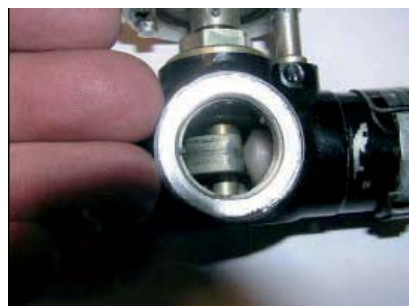
The aircraft had recently undergone

maintenance on the fuel system following a fuel leak. The investigation discovered that the internal cam which blocked off the unwanted fuel line in the fuel selector had been replaced 180 degrees out. Selecting left tank on the lever was actually supplying fuel from the right tank and vice versa, as shown in the [pictures].

While we would hope that an engineering organisation's procedures would detect such errors, everyone can make a mistake. We frequently remind pilots to be extra careful in their pre-flight checks following an aircraft's return from maintenance, and to be prepared for things to go wrong. Anything unusual should be double checked.
