www.caa.co.uk/gasil

Issue no 9 of 2010

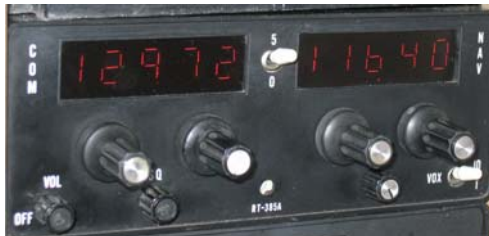
A Cessna 172 was given clearance to line up on the active runway, but no further message was received from Air Traffic Control. While the Cessna waited for further clearance, a commercial airliner abandoned its approach and flew a go-around, because all its pilot could hear on the Tower frequency was background noise from inside the cockpit of the Cessna. The Cessna's radio had become stuck on permanent transmit, apparent because of a fault in the radio set itself.

We have advised in the past that if all radio reception seems to have ceased, especially when we are expecting a message from an Air Traffic Service Unit, that we should suspect that our own transmitter may be transmitting, and seek to resolve the problem. Unfortunately, if we are already listening to a different frequency on a second radio, we might not detect the problem immediately.

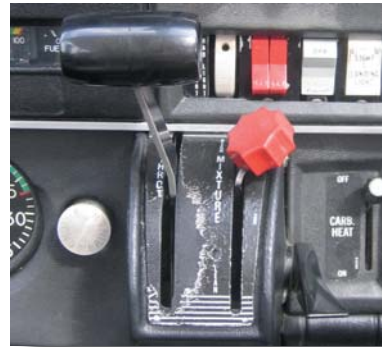
Last month's Occurrence listings included an incident of a PA28 which suffered a restriction in its throttle movement in flight. The instructor apparently set the aircraft up for a glide approach at an aerodrome with a long runway and shut down the engine before making a safe landing. The cause of the restriction was caused by a apparently a clamp on the throttle cable which had come loose.

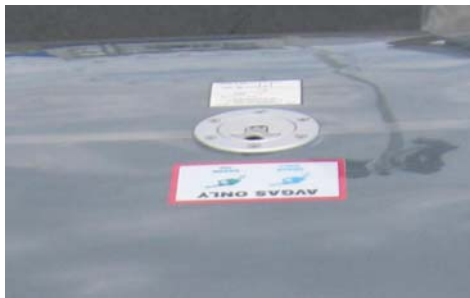
File photo

The AAIB's Bulletin 4 of 2010 includes a report of an accident following an engine failure at about 50 feet after take-off. It seems that the pilot was able to land back on an available runway, but because he had selected the gear up immediately after the aircraft lifted from the runway, the undercarriage was still up when it landed, and the aircraft was damaged.

According to the report, the cause of the engine failure, however, was probably water in the fuel tank, possibly entering through a wrongly fitted fuel filler cap. Similar cases have been reported in the past, and, as in this case, discarding a fuel sample containing water and apparently finding none in the next sample has not always proved that all water has been removed if a significant quantity of water has entered the tank.

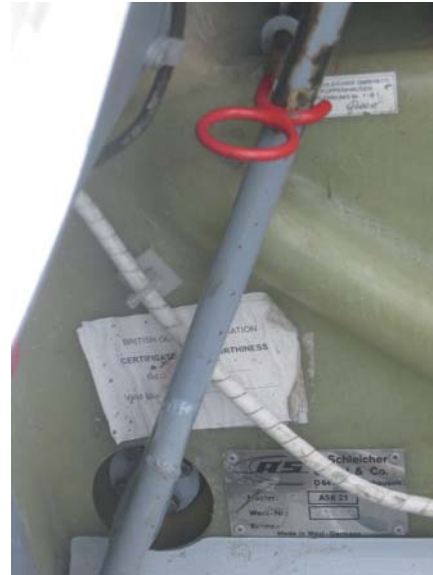
Following a recent daily inspection on a K21 glider it was noticed by another pilot that the front of one of the main pins was about a centimetre proud of its correct position. The pilot who had carried out the previous inspection frankly admitted that he had checked, as was his habit, only that the red safety clip was holding the pin handle, and had not noticed the pin itself was out of its correct position.

The correct position is illustrated. The mis-alignment of the pin may well not have caused serious problems, as it was found difficult to move it during the subsequent re-rigging. However we should all reflect on the old maxim: "Don't assume, check!"

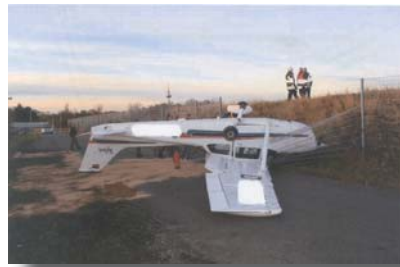
As reported recently by the BFU (German AAIB), a Cessna 172 pilot who had received clearance to land from a straight-in approach found his touchdown point would be more than half-way along the runway. The report notes that marks on the runway indicated that he had started to apply the brakes with 260 metres of runway remaining, but believing he was unlikely to stop before the end, he applied power in an attempt to go-around. The aircraft over-ran the end of the runway and came to rest inverted at the bottom of a bank as illustrated.
