www.caa.co.uk/gasil

Issue no 1 of 2011

Fuel drains

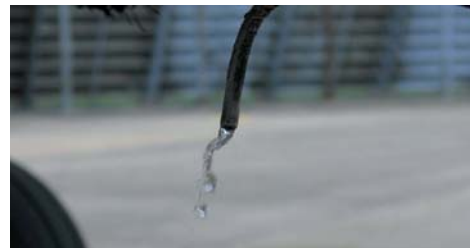
File photo

Some 10 minutes after take-off the engine stopped, with the fuel tanks both indicating empty. During the subsequent forced landing, the aircraft was damaged and the occupants suffered minor injuries. The fuel loss was attributed to the fuel strainer drain sticking partially open after the pre-flight check. This had possibly been caused by contamination by a waxy substance commonly found when water had been present in the fuel some time previously.

The loss of fuel through a stuck drain valve has been known to reduce engine power significantly during take-off. Although we stress the importance of carrying out checks of the fuel drains for water and other contaminants, it is vital to ensure that the valve re-seats correctly after the check and no drips remain.

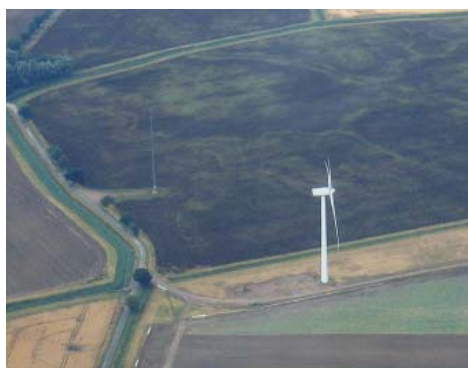
Pilots have recently expressed concern that anemometer masts have been erected in areas proposed for use as future windfarms. Others have been erected adjacent to but outside the current windfarm boundaries. As can be seen from the photograph, these masts are relatively thin, and difficult to pick out from the air. Being less than 300 feet high, they are not required to be lit, or marked on CAA charts (and the sheer numbers of them would cause considerable clutter anyway), nor to be subject to NOTAM action unless they are considered by the aerodrome operator to affect safe operations around licensed aerodromes.

There is no VFR minimum flying height mandated in UK airspace, so pilots may find themselves, quite legally, confronted by one of these anemometer masts while believing they are separated by 500 feet from persons, vessels, vehicles and structures. Some power companies are to be congratulated for attempting to increase the visibility of these masts, but the hazards they pose to aircraft, including helicopters which fly at low heights in poor visibility, are obvious. Except perhaps in areas with which you are particularly familiar and have checked very recently, we can only recommend avoiding flight below 500 feet above ground in poor visibility!
